CHRONICLING THE DEGRADATION OF A 345 kV GENERAL ELECTRIC TYPE U BUSHING

**Richard Wancour, P.E. and Stephen Molter, ITC Holdings Corp.
Robert C. Brusetti, P.E., Doble Engineering Company
Eric Weatherbee, Hubbell Power Systems/PCORE**

ABSTRACT

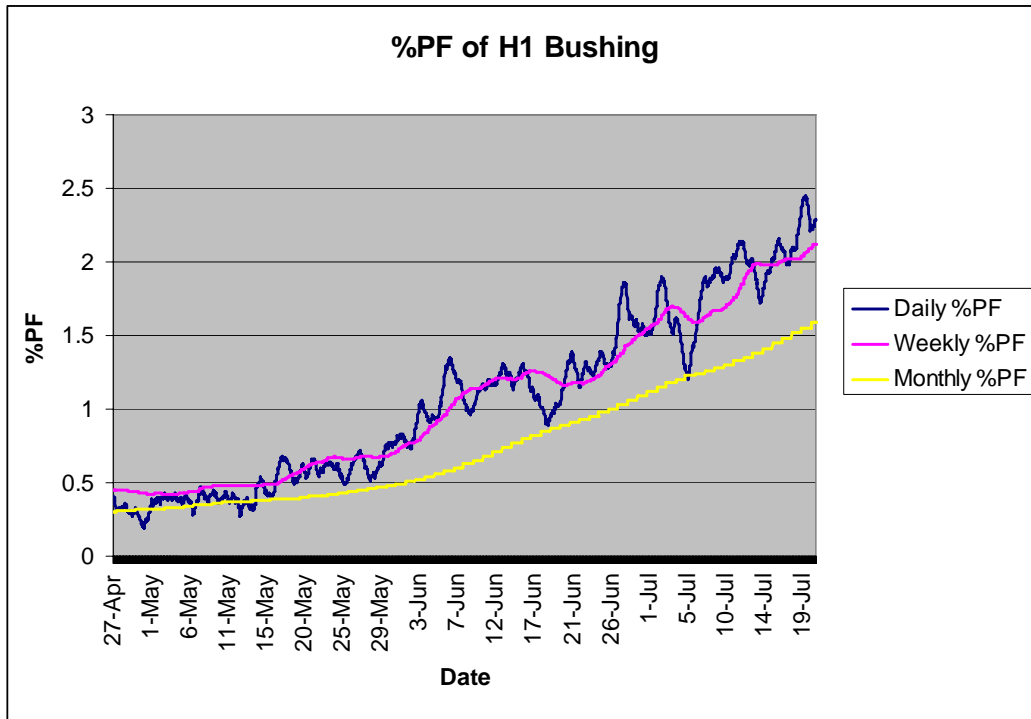
In this instance, the alert being generated by the expert system was based on the monthly trend of the H1 bushing's power factor that had exceeded the 1% threshold. A review of the last three months of data revealed that the H1 bushing had been manifesting an increase in power factor, and that increase had accelerated during the second week of June. As of the morning of July 11th the on-line expert system was

Figure 1 plots the H1 bushing's power factor from April 27th through July 21st, this was calculated from the on-line leakage current measurement at the bushing tap using the three trending intervals; Figure 2 represents the capacitance calculation utilizing the same information. With reference to the monthly data, shown in Figures 1 and 2, a correlation between the on-line data reported by the monitoring system can be made with the off-line test results shown in Table 4 and 5 (performed in March). Both of which suggest that little or no degradation of the H1 bushing had occurred up to that point. The power factor results exhibit a very gradual increase through the end of May when the power factor is approximately 0.5%, after this the rate increases more significantly. The overall increase in capacitance is far less significant and on its own does not justify an investigation. Both the on-line and off-line results indicate that the deficiency is related to the quality of the dielectric and not to the physical composition of the bushing.

**% Power Factor of H1 Using On-line Measurements
FIGURE 1**

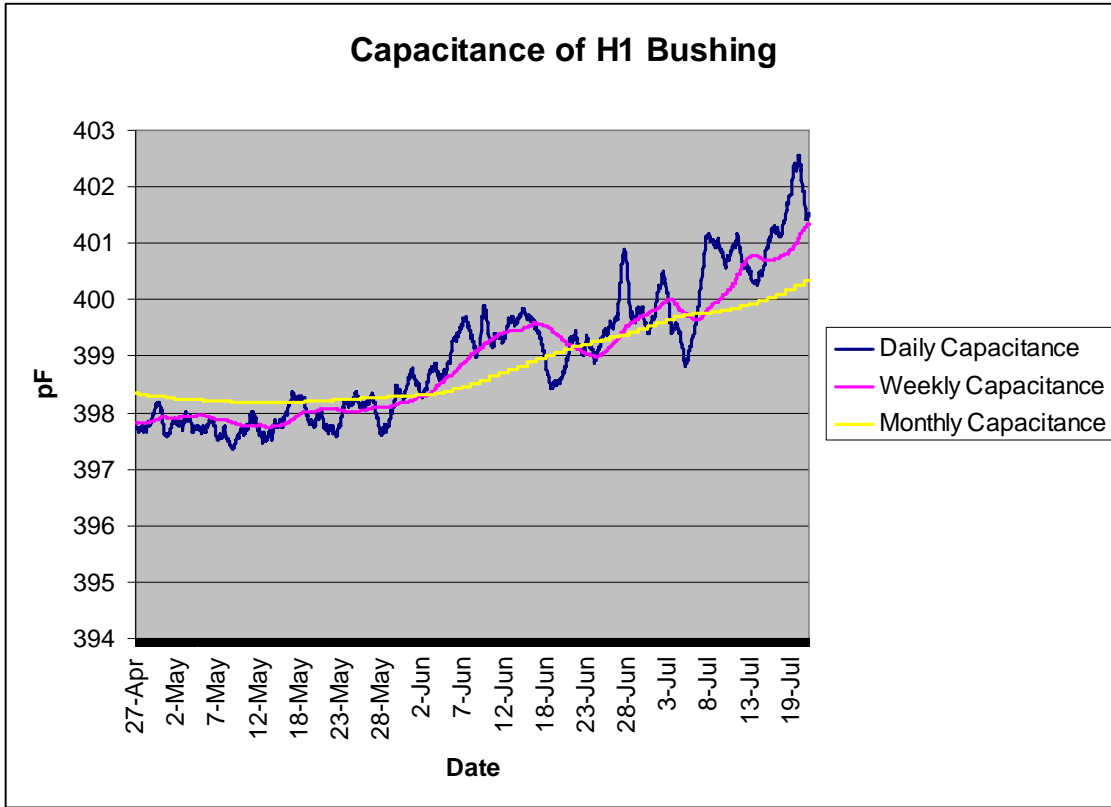
**Capacitance of H1 Using On-line Measurements
FIGURE 2**

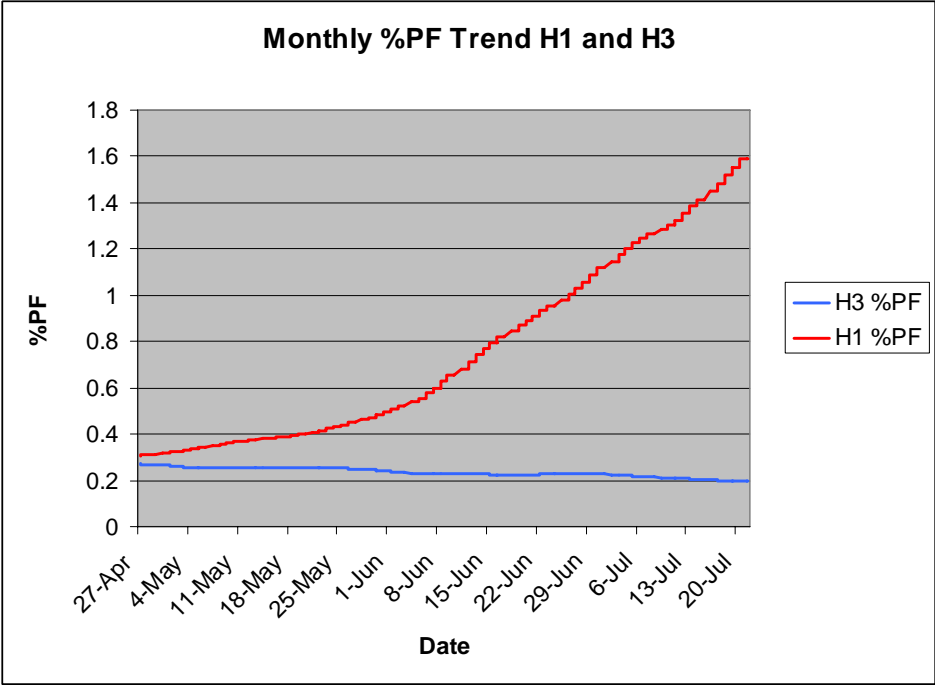
Figure 3 represents the monthly power factor trend of the two non referenced bushing, H1 and H3, which correlates well with their off-line measurements. Figure 4 goes through a similar exercise using the capacitance of the H1 and H3 bushings.

**% Power Factor of H1 and H3 Bushing Using On-line Measurements
FIGURE 3**

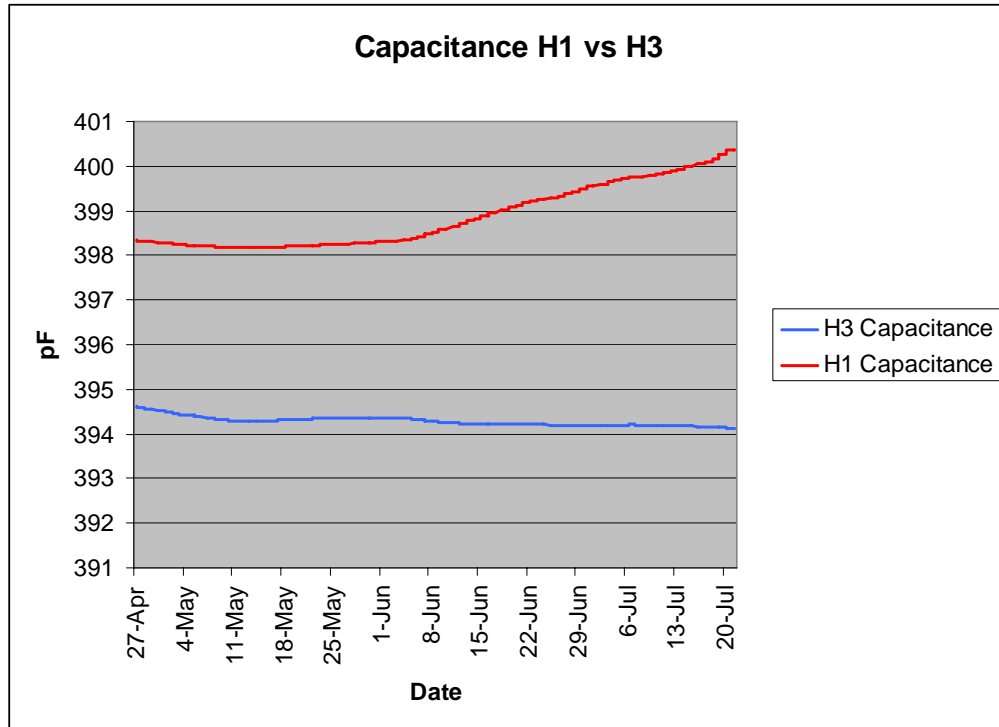
**Capacitance of H1 and H3 Bushing Using On-line Measurements
FIGURE 4**

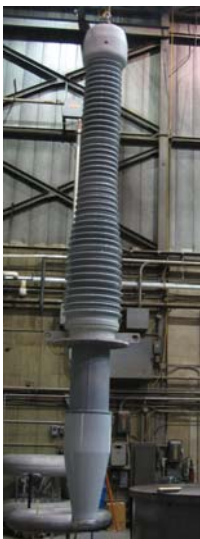
Figure 5 shows the bushing in tack, and Figure 6 illustrates the bushing with the outer weather shed removed. The bushing condenser design employed electrical grade paper with a metallic foil layer periodically incorporated in the wrapping. The core construction consisted of 440 turns of paper and 42 foil layers. This design eliminated one of the more common failure mechanisms of the GE Type U bushing which is ink migration (herringbone design) to the insulating layer, which may lead to partial discharge and/or overheating of paper.

H1 Bushing Intact
FIGURE 5

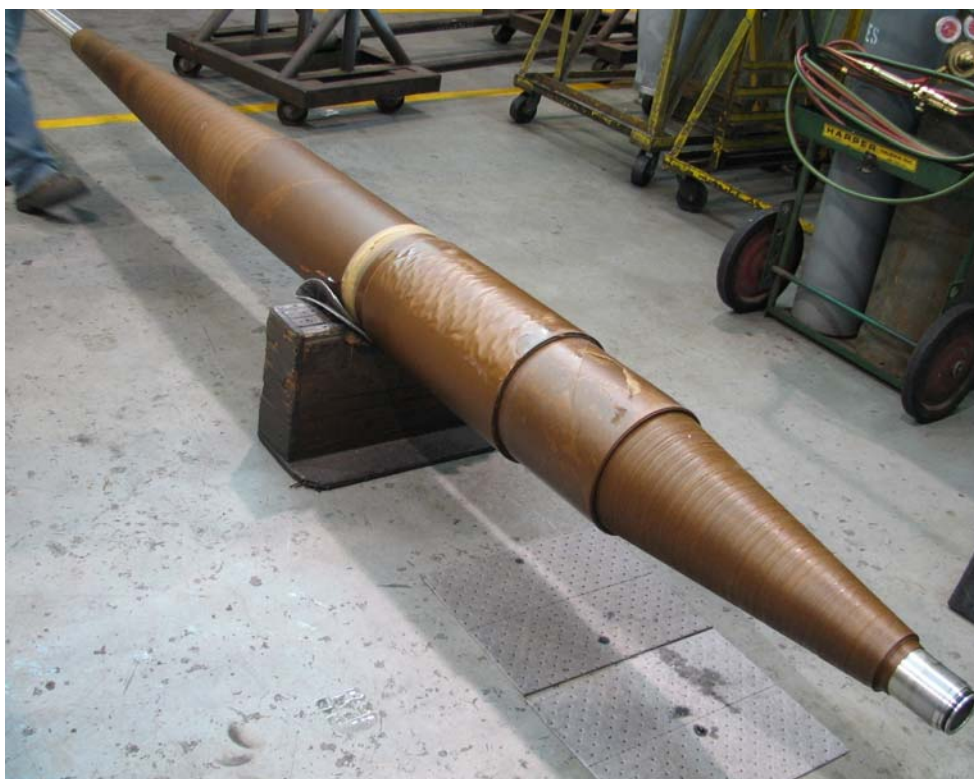
H1 Bushing Core
FIGURE 6

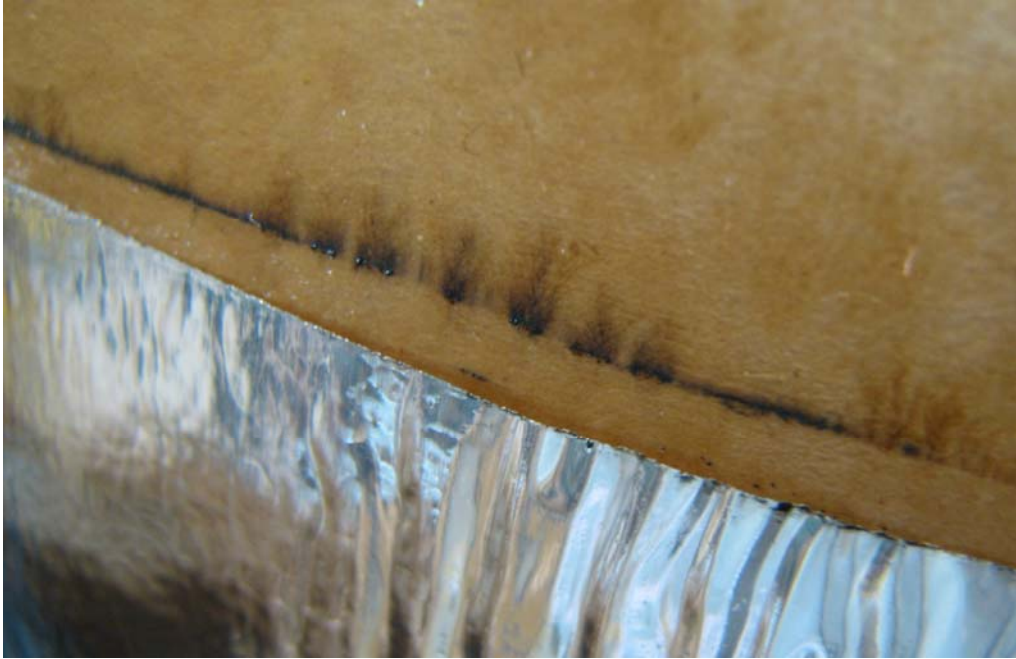
As the paper was unwrapped discoloration was observed on the paper at the foil edge (Figure 7) and conduit used to bring the tapped condenser layer out to the bushing capacitance tap (Figure 8). Minor wrinkles/waves were noted on most foil layers however no abnormality (discharge activity) could be attributed to this particular deficiency (Figure 9).

Discoloration at Foils Edge, H1
FIGURE 7

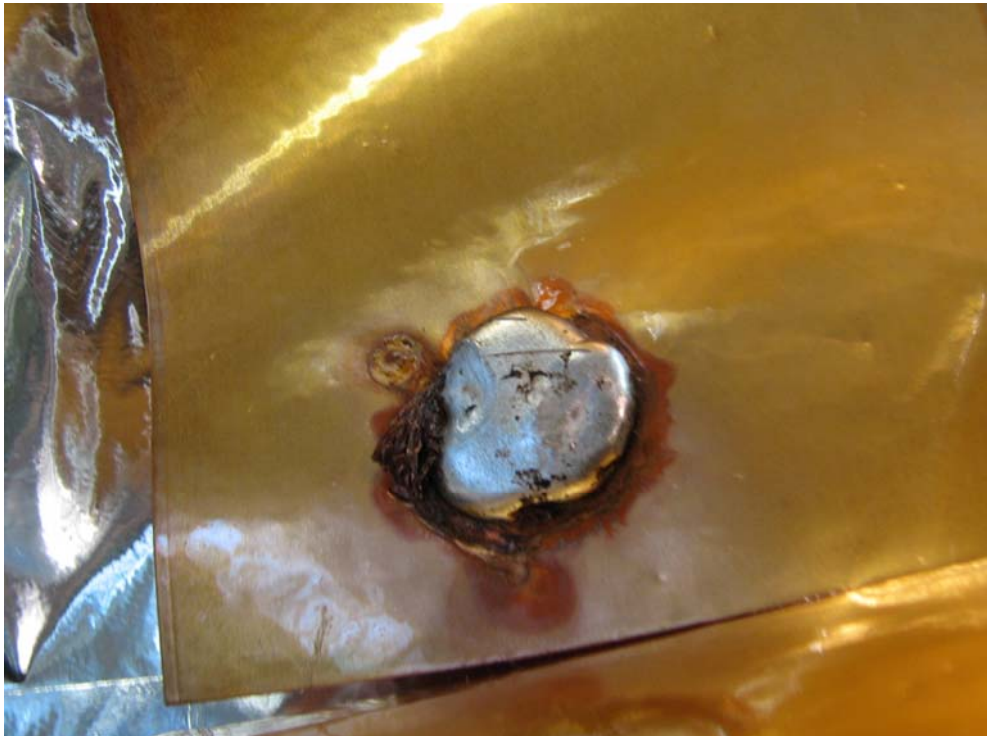
Discoloration at Tap Layer Interface, H1
FIGURE 8

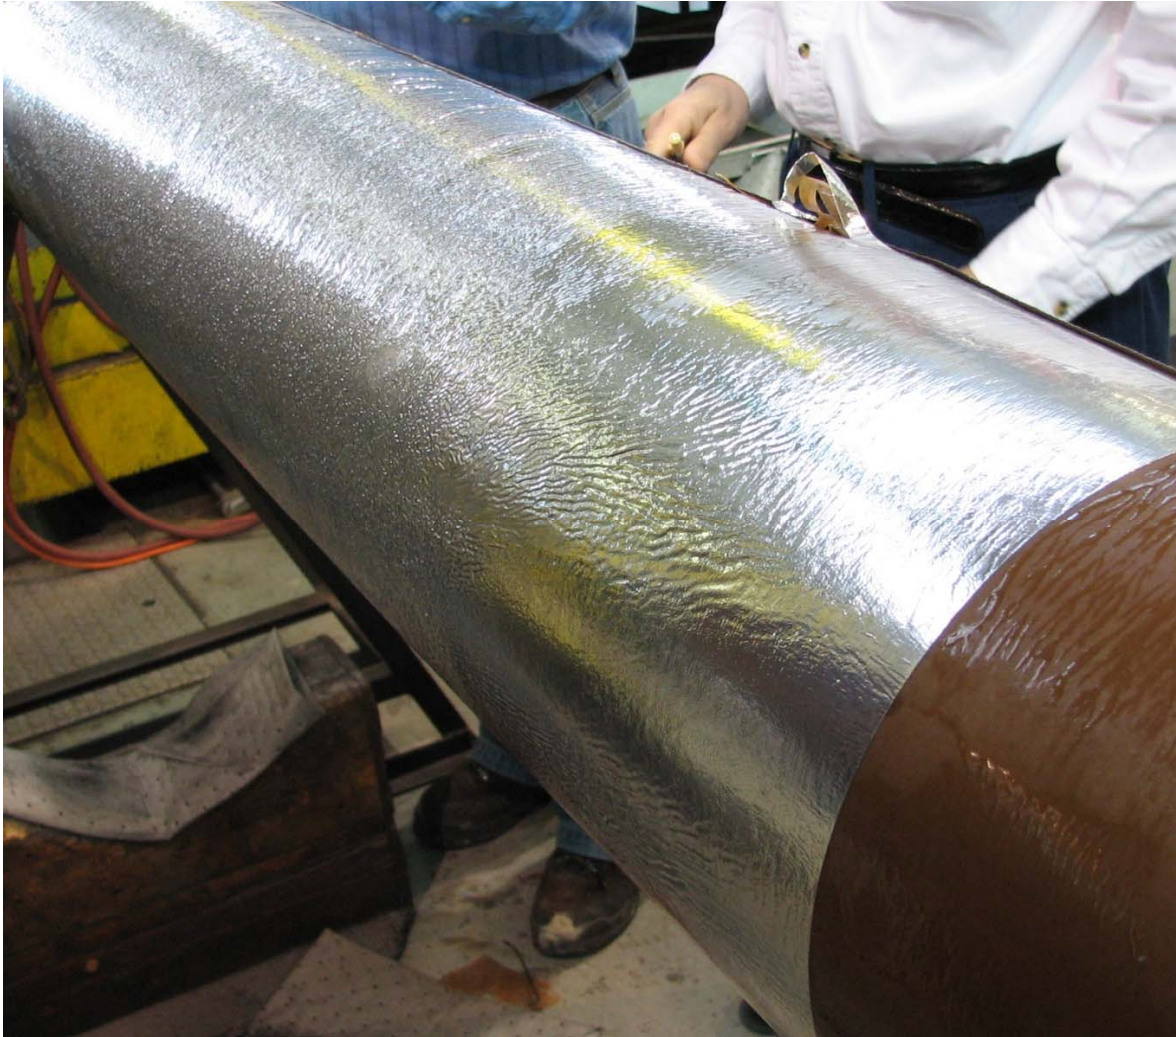
Wrinkled Foil, H1
FIGURE 9

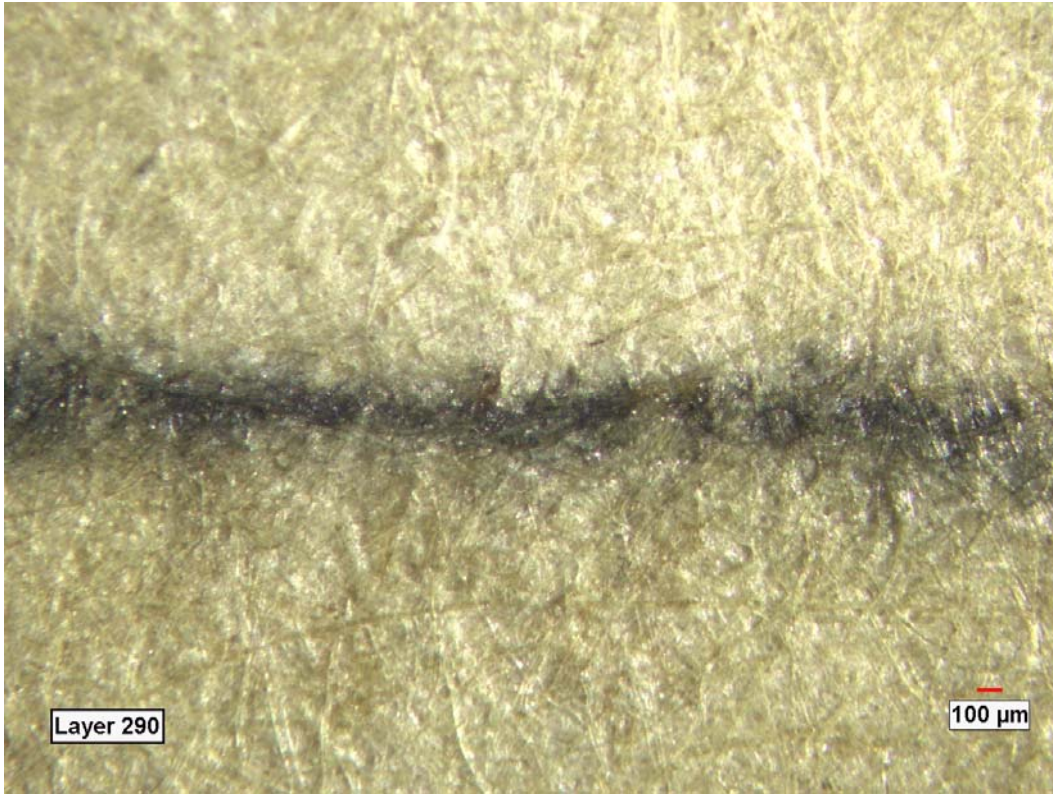
LAYER	DP	CAP (pF)	%PF	OBSERVATION
Bumper Shell				Small mass of bluish-green material observed elemental composition titanium, calcium, iron and silicon.
1	713	408	0.07	
24	759	410.4	0.10	Tree like tracking along foil's edge with significant embedded burning. Silver colored fines where foil made contact with paper and also in treeing location. Elemental composition of the treeing area showed carbon at about 56%, oxygen at 43% and copper, sulfur and chlorine at less than 1%. The fines were mainly composed of copper and sulfur indicating possible copper sulfide.
50				Some tree like tracking along foil's edge and area where foil makes contact with paper, silver colored fines along foil's edge
170				Discoloration, result of deposits (no burning), substantial amount of silver fines on paper where foil makes contact
290	992	416.2	0.14	Both deposit and tree like tracking make up the discoloration, left side deposit and right side deposit. No silver color fines on this sample. Elemental composition of the deposits showed carbon and oxygen present but of more interest where the elevated concentrations aluminum, copper and sulfur. Although burning of the paper was most likely occurring, deposition of aluminum, copper and/or their sulfides was the primary reason for the deposition that occurred in this area, see Figure 10.

**H1, DEPOSIT ON PAPER LAYER 290 MAGNIFIED X66
FIGURE 10**

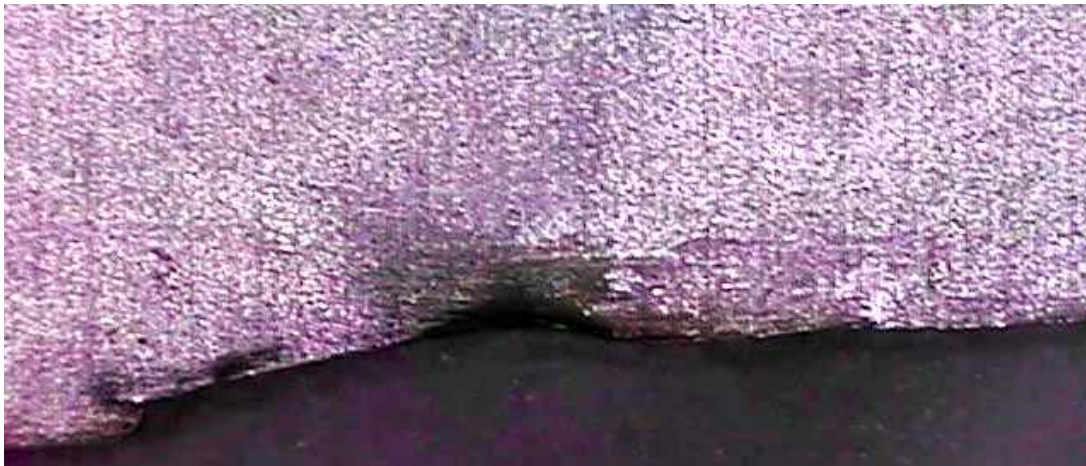
**H1, BURNT FOIL EDGE x35 MAGNIFICATION
FIGURE 11**

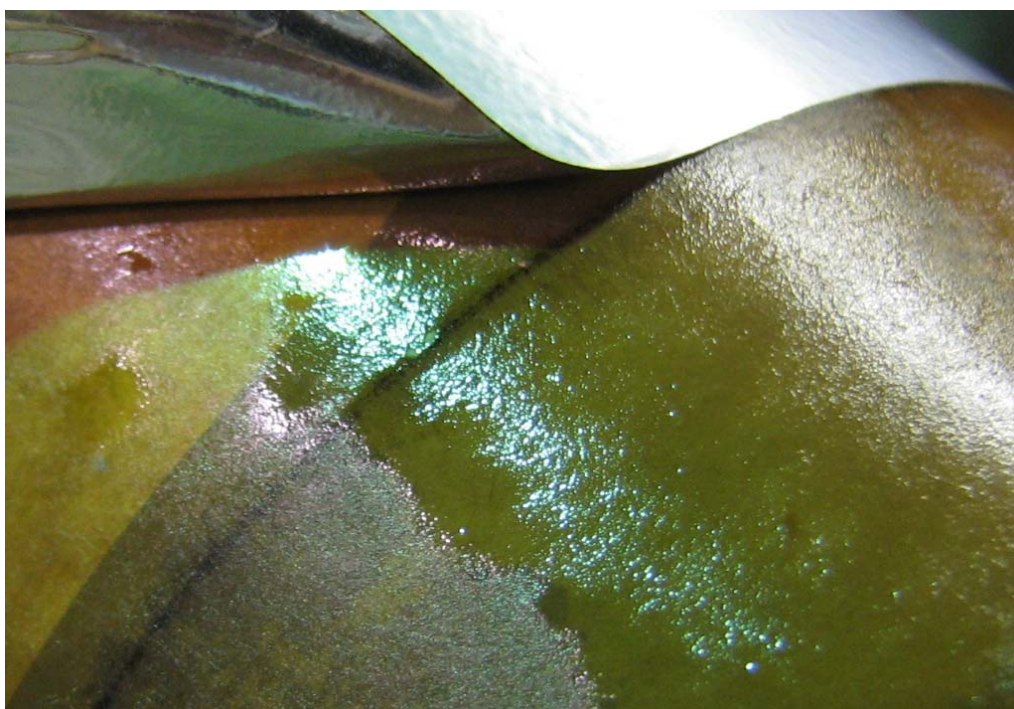
The H3 bushing was confirmed to be in good condition through factory electrical testing, which agreed with the results obtained through the on-line monitoring system. However, the disassembly of the bushing seems to indicate early stages of the same phenomenon that affected the H1 bushing. Figure 12 shows one of the discolorations areas along the foil's edge found within H3 bushing that is similar to the ones observed in H1 bushing core

**H3, Discoloration Along Foil's Edge
FIGURE 12**
