PTFE EXPERIENCES IN TOUGH CONDITIONS

Damage caused to bearing pads

GUIDE BEARING FAILURE IN THE SAME POT AS THE PTFE THRUST BEARING

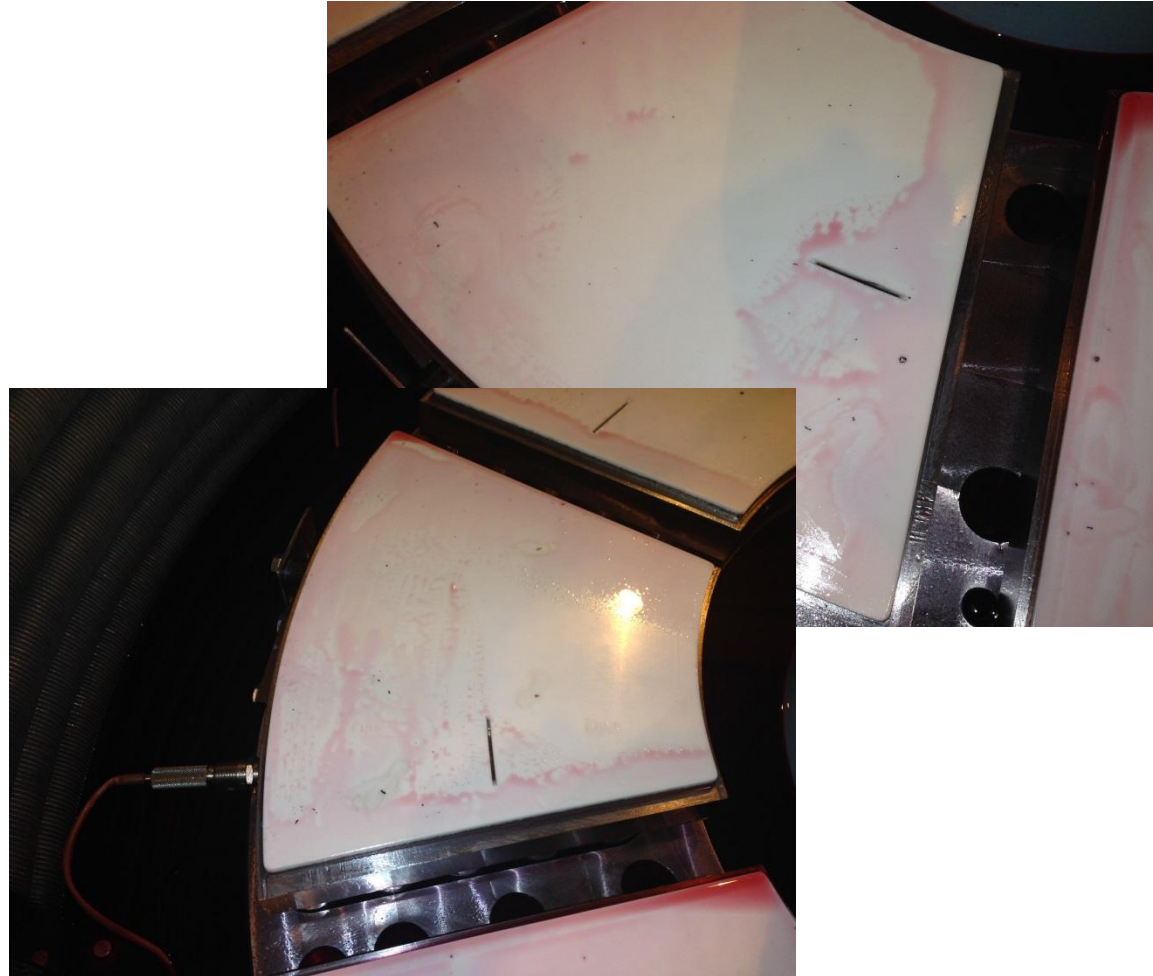
The Babbitt guide bearing wiped causing Babbitt to be circulated throughout the bearing pot. The specs on the white surface is Babbitt stuck to the PTFE. This Babbitt was easily wiped off. The thrust bearing is currently in operation.

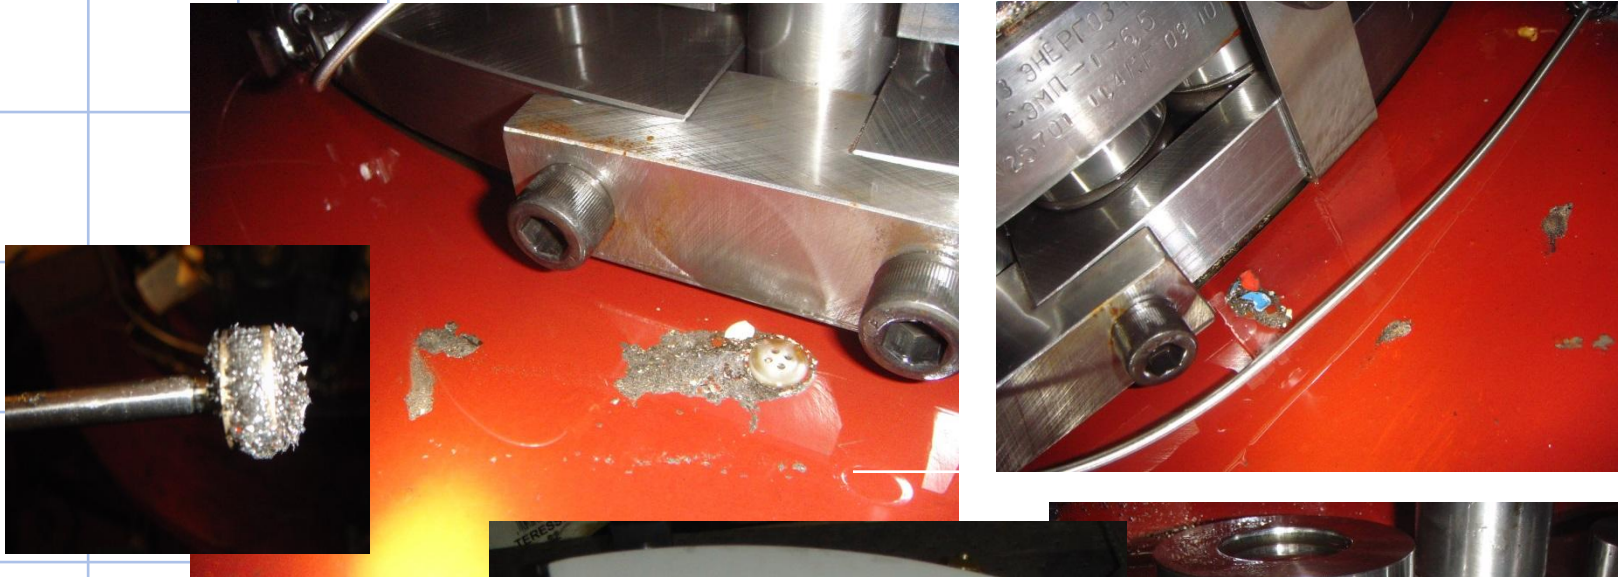
GRINDING, FILINGS, AND PAINT IN THE PTFE THRUST BEARING

Debris found in the bearing pot after one year of operation.

The bearing was cleaned with no further repair required.
